CF6-6D ENGINE SHORT-TERM PERFORMANCE DETERIORATION

W.H. Kramer, J.E. Paas,
J.J. Smith, and R.H. Wulf

GENERAL ELECTRIC COMPANY
AIRCRAFT ENGINE GROUP
CINCINNATI, OHIO 45215

NASA Lewis Research Center
Contract NAS3-20631

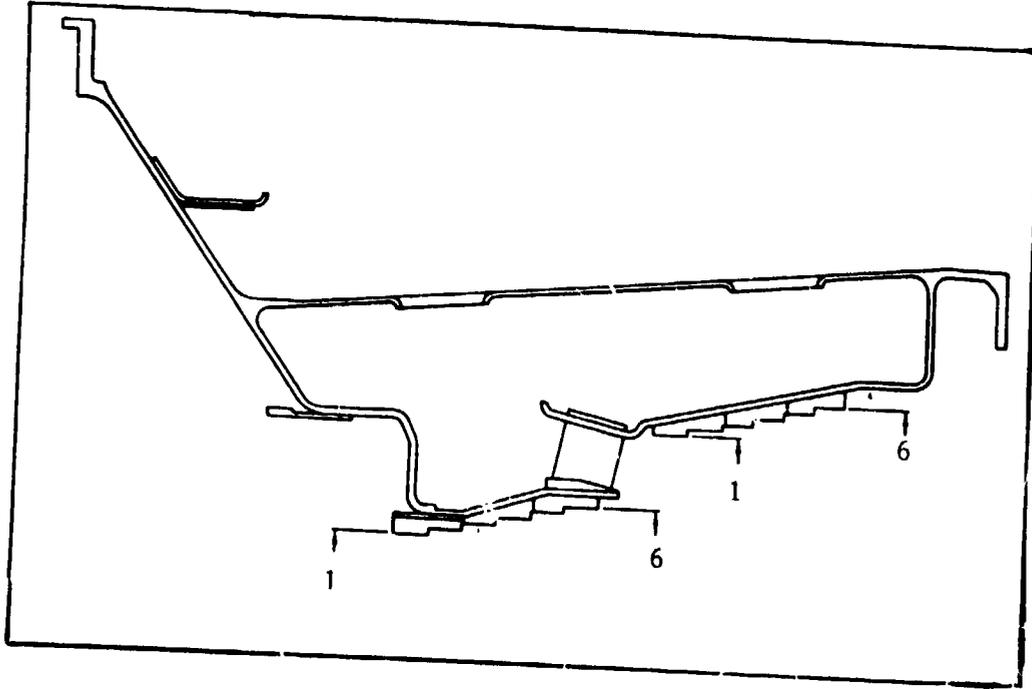
Figure B-9. No. 4B Pressure Balance Seal (Mini-Nozzle).

A visual inspection of the No. 4B pressure balance seal, Figure B-9, showed it to be in excellent condition with only very slight rubs located at approximately the six o'clock position. Dimensional inspections consisting of measurements of eight equally spaced diameters were made on each land of each of the aft seals. This seal structure provides the stationary seal surface for both the aft CDP seal and balance piston seal. These measurements are presented in Tables B-X and B-XI, while the inspection data for the rotating seals are presented in Tables B-XXIX and B-XXX in Section B.3.3 of this report. The resultant clearances are shown in Tables B-XII and B-XIII. Note that the 0.010 inch average clearance of the aft CDP seal is the nominal value for stackup of production/new hardware. The balance piston seal was within 0.0005 inch of its nominal stackup of 0.010 inch.

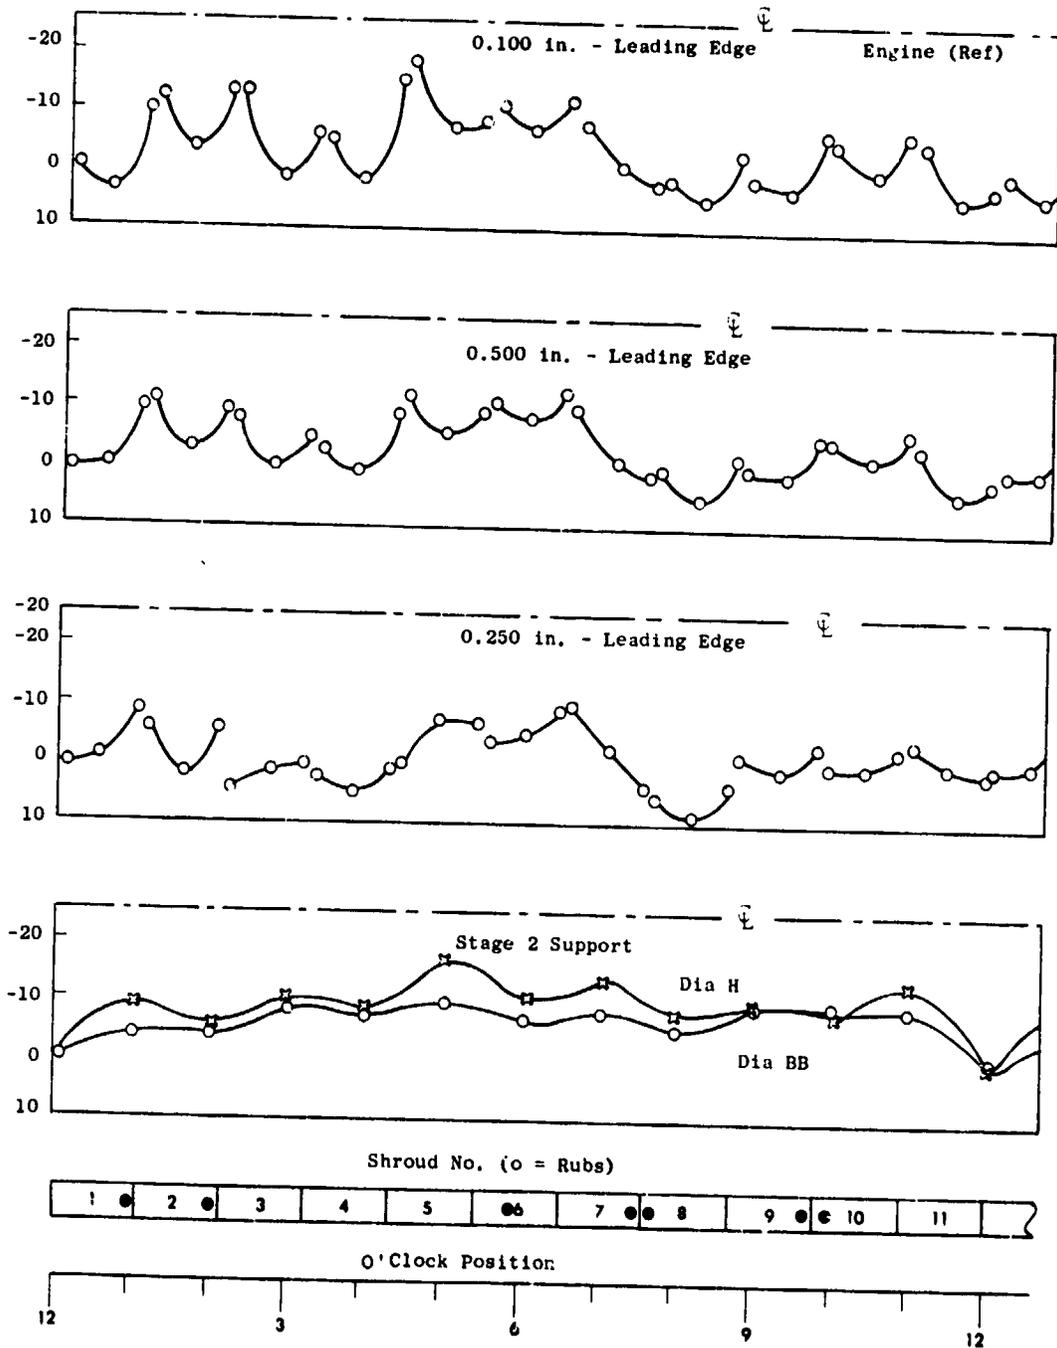
Figure B-19. Stage 2 HPTN Support and Stage 2 Shroud Runouts.

Figures B-19 and B-20 depict the shrouds and the support runout data, together with the locations of the shroud rubs.
